# Manhole Inspection Summary

Manhole # S23KK\_060MH

**Location** Address: **2454 ETING ST**

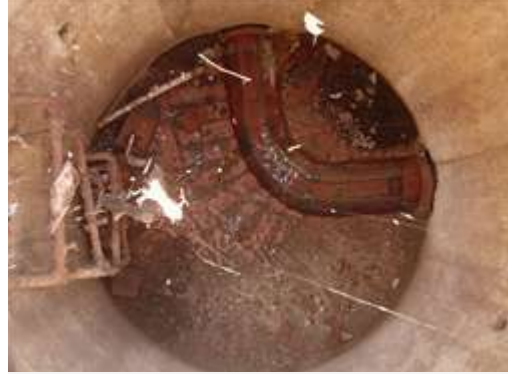
Top View

Corroded steps. Evidence of surcharge - Bench debris.

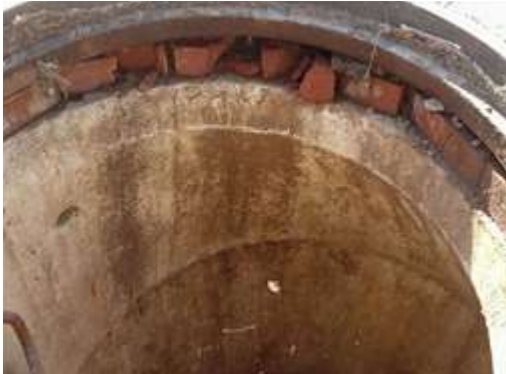
Defect

Frame leaks. Adjustment deterioration, loose brick and infiltration. Corbel and Barrel infiltration - other side.

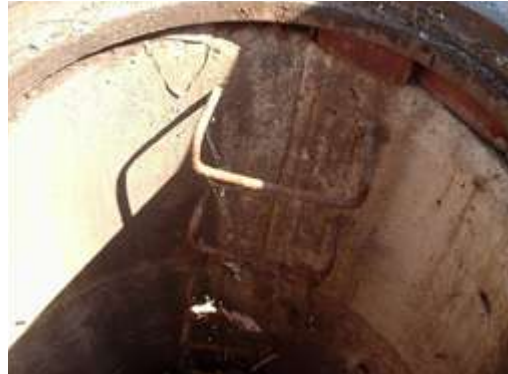
Defect

Frame leaks. Adjustment deterioration, loose brick and infiltration. Corbel and Barrel infiltration.

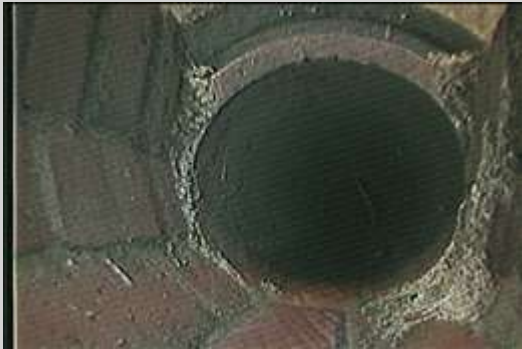
Pipe Out @ 12 O'Clock

Infiltration: **Evidence** Pipe Seal Cond: **Unknown**

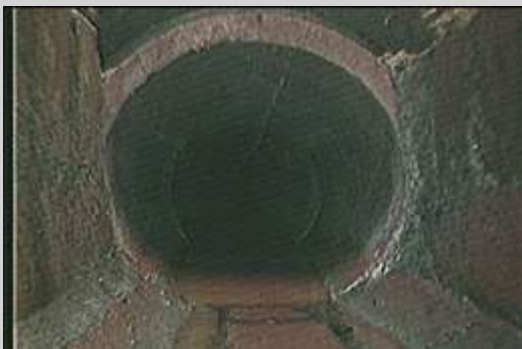
Pipe In @ 3 O'Clock

Infiltration: **Evidence** Pipe Seal Cond: **Unknown**
